*July 16, 2010*

# Recent efforts to improve the water quality of Lower St. Johns River tributaries

**Cheryl M. Wapnick**

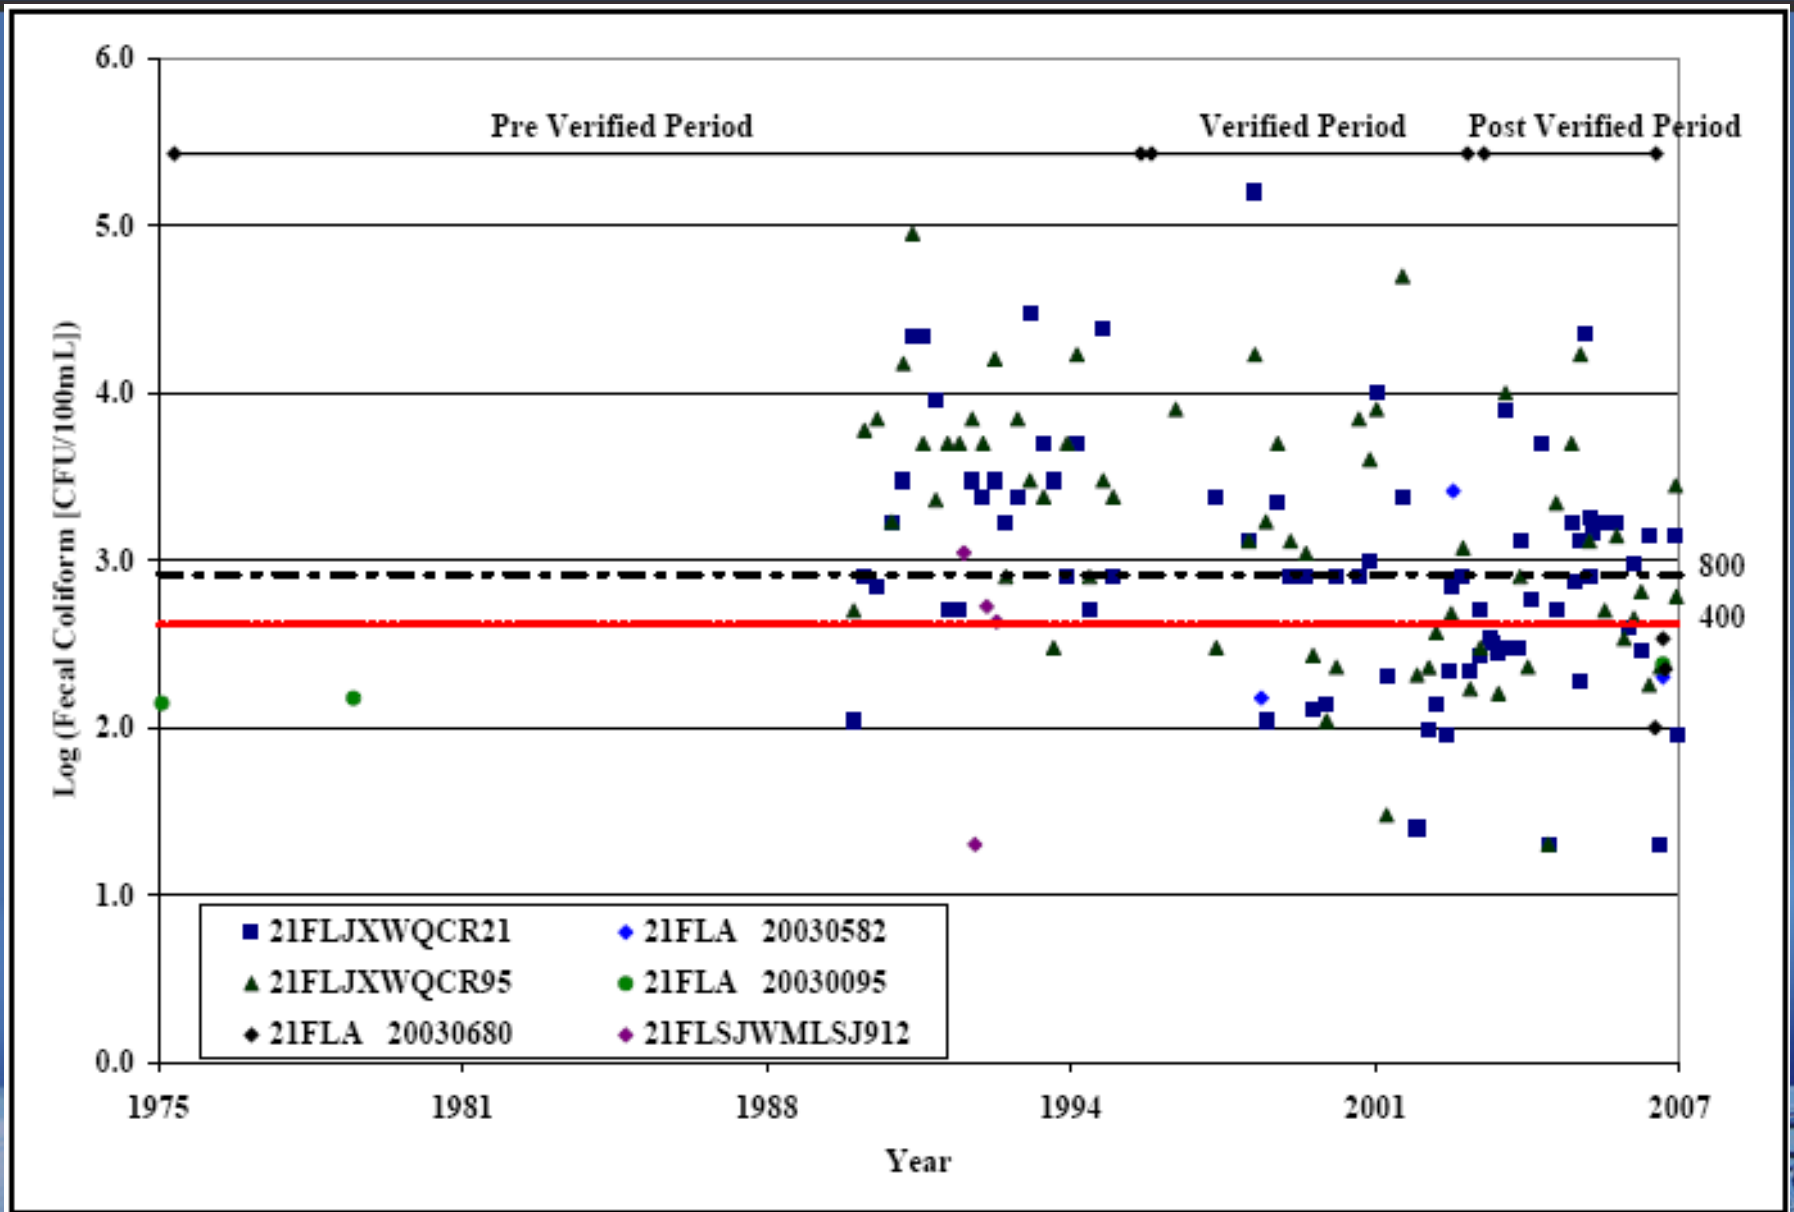
# Time Series Analysis of FC Data

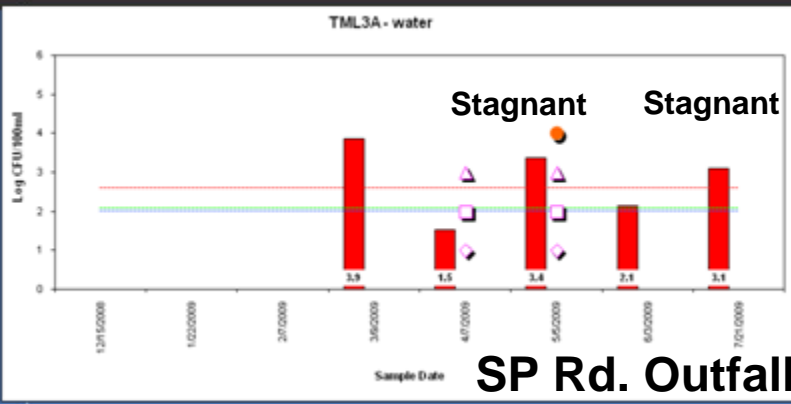
SP Rd. Outfall  $esp = 0.0006\%$ ;  $<1\%$  human contamination

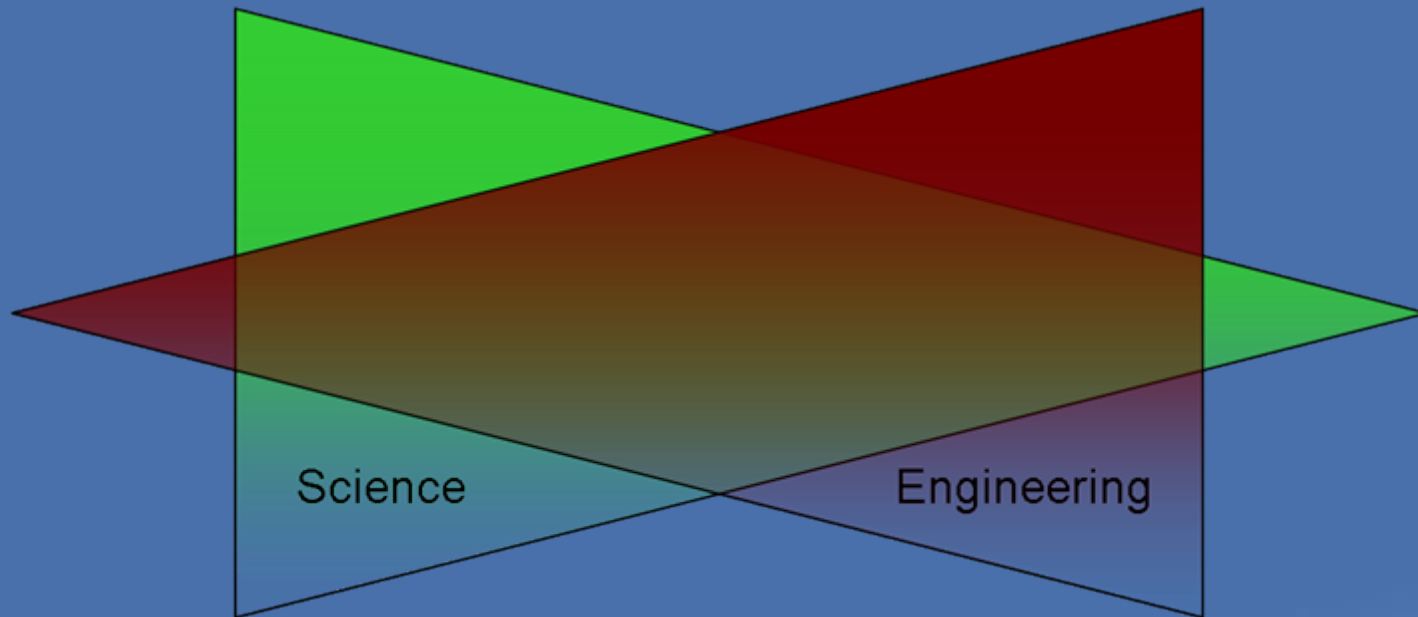
Observe → Analyze → Design → Construct

**Need sound science to have sound engineering**

**Facts**  
(limited or no interpretation,  
not applied in context)

**Misapplied science**  
(one size fits all, out of  
context)

**Place-based science**  
(local knowledge &  
wisdom applied in context)
