Summary Report of Walk Audits in Phoenix Neighborhood

November 6, 2018

Dates of Walk Audits: February 15, July 31, and August 7 in 2018

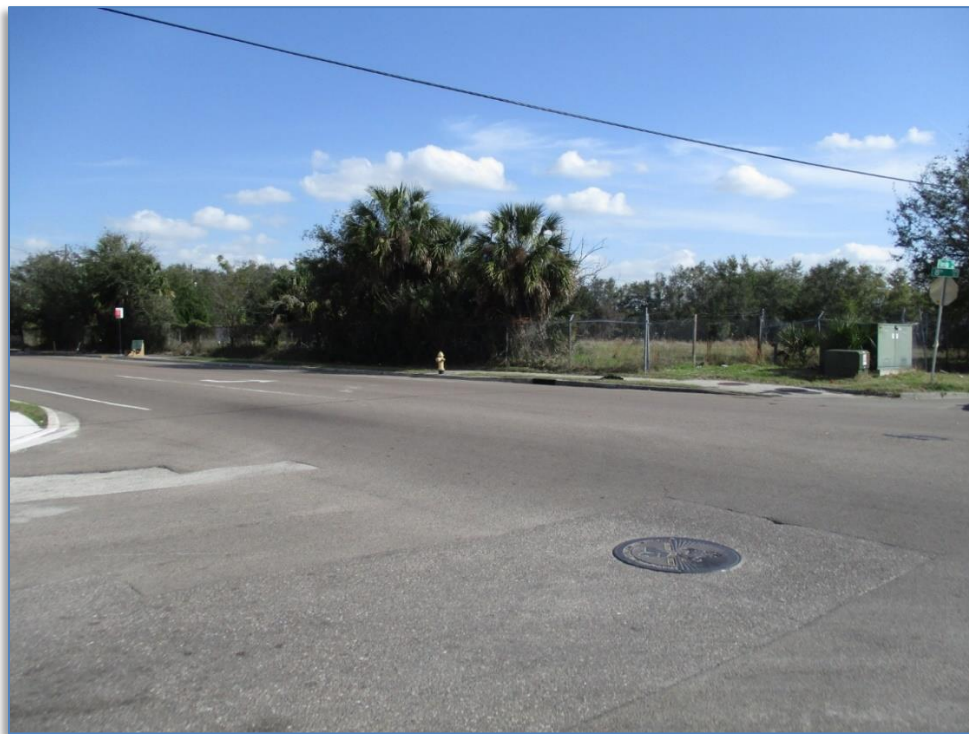
Figure 3 shows Florida Avenue & 8th Street, which is one of two streets that cross over the railroad tracks to the south, leading to the adjacent neighborhood. Without signage or marked crossings, drivers are not likely expecting pedestrians to cross at Phoenix Avenue, Florida Avenue, or Franklin Street, however several people were observed crossing at all three locations. Pedestrians and/or bicyclists were recorded at nearly half of the intersections that were observed, for a total of 42 pedestrians. For the level of pedestrian activity observed, especially in the middle of the day on a weekday, there could be better and a lot more marked crossings. However, based on the low traffic volume, relatively short crossing distances, and fairly consistent presence of curb ramps.

Figure 3: Long crossing with no marked crosswalk at Florida Avenue & 8th Street

- Southbound at 12th Street
 - Northbound at 11th Street
- Add a Rectangular Rapid Flashing Beacon or other enhanced crossing across 8th Street at Florida Avenue

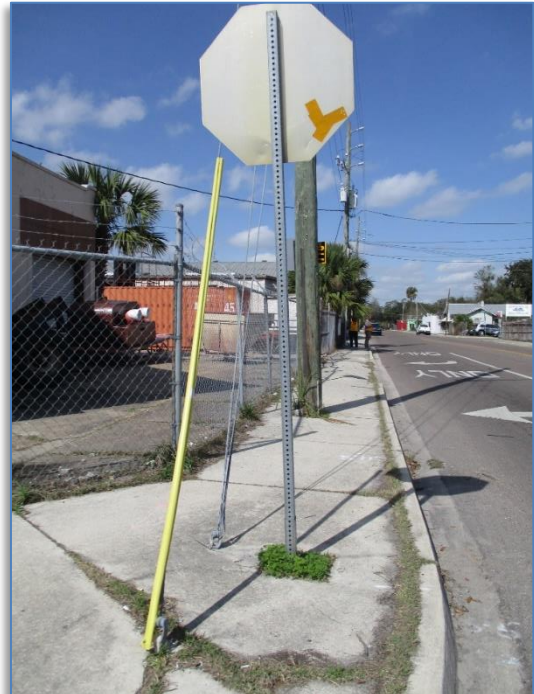
The Study Area was broken up into 46 segments for this Assignment. In most of the Study Area, sidewalks were blocked by poles and overgrown grass and vegetation. There are many cracked and severely broken sidewalks all throughout the neighborhood. Several segments have no sidewalks at all. In a number of locations it is difficult to tell if the sidewalk is missing or simply covered by overgrown grass and weeds. There are some locations where trash has been dumped, blocking the sidewalk. Several vehicles parked on the sidewalk, particularly in the west side of the neighborhood where there are industrial buildings. Rarely is there a grassed buffer between the sidewalk and the street. Where curb ramps are present, they are often not ADA compliant. Figures 4 – 11 illustrate these issues.

Figure 4: Utility poles and signs block the sidewalk

- Edge all sidewalks where grass is encroaching
- Fix potholes in the streets
- Remove abandoned wooden poles in the sidewalk
- Fix hanging wires from utility poles

- Relocate AT&T poles throughout neighborhood where possible
- Conduct regular litter pick-up
- Ensure that bulk garbage pick-ups are being made
- Increase in law enforcement presence and issuance of warnings and citations to careless drivers

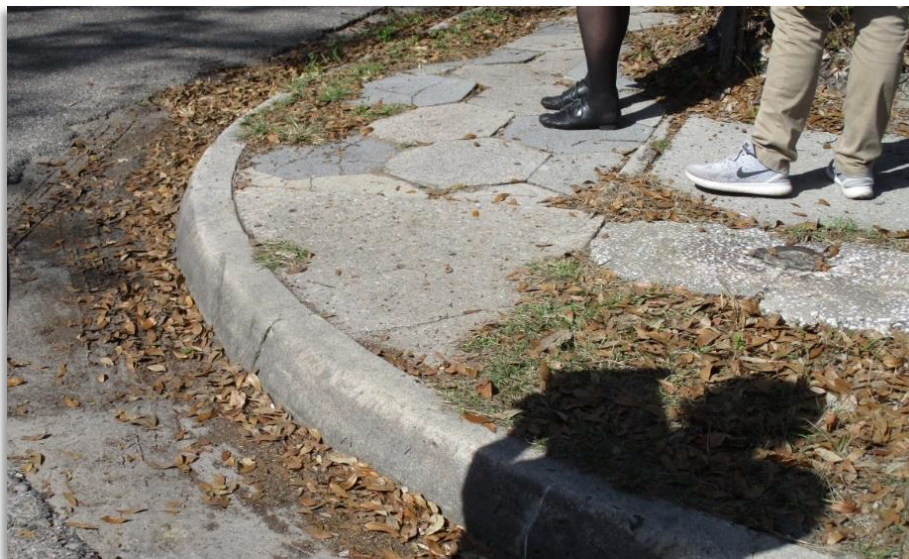
Figure 5: Broken sidewalk with no curb ramp

- Stripe stop bars and crosswalks at all stop-controlled intersections
- Bring all existing curb ramps to ADA compliance, and add new ramps where there are none

- Fix all broken and cracked sidewalks
- Construct new sidewalks on at least one side of the street on those blocks where there are none, and fill small gaps that currently exist between sidewalk segments

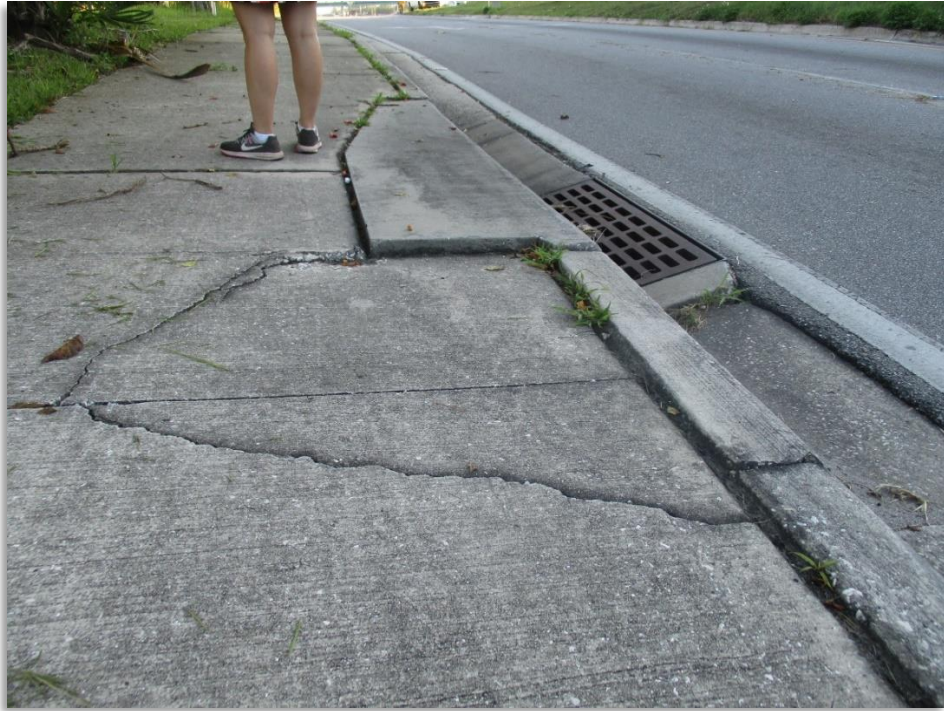
Figure 6: Severely broken sidewalk with no grassed buffer

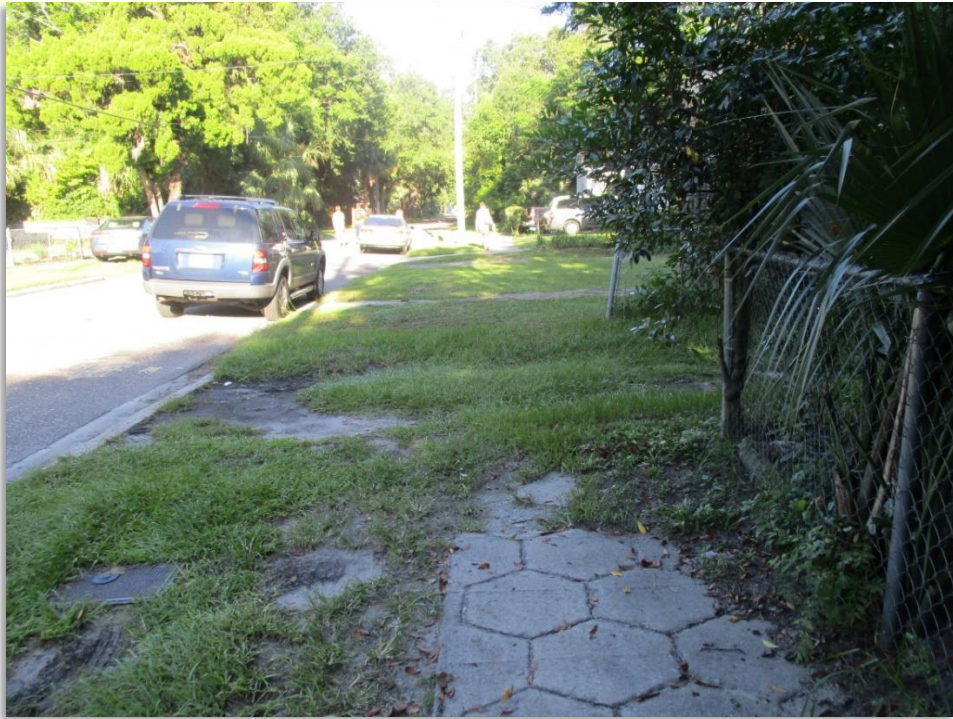
Figure 7: Sidewalk with overgrown vegetation, with potential sidewalk gap

- Trim all vegetation/remove downed trees in the public right-of-way so that the sidewalks are clear and sight distance at intersections is not obstructed

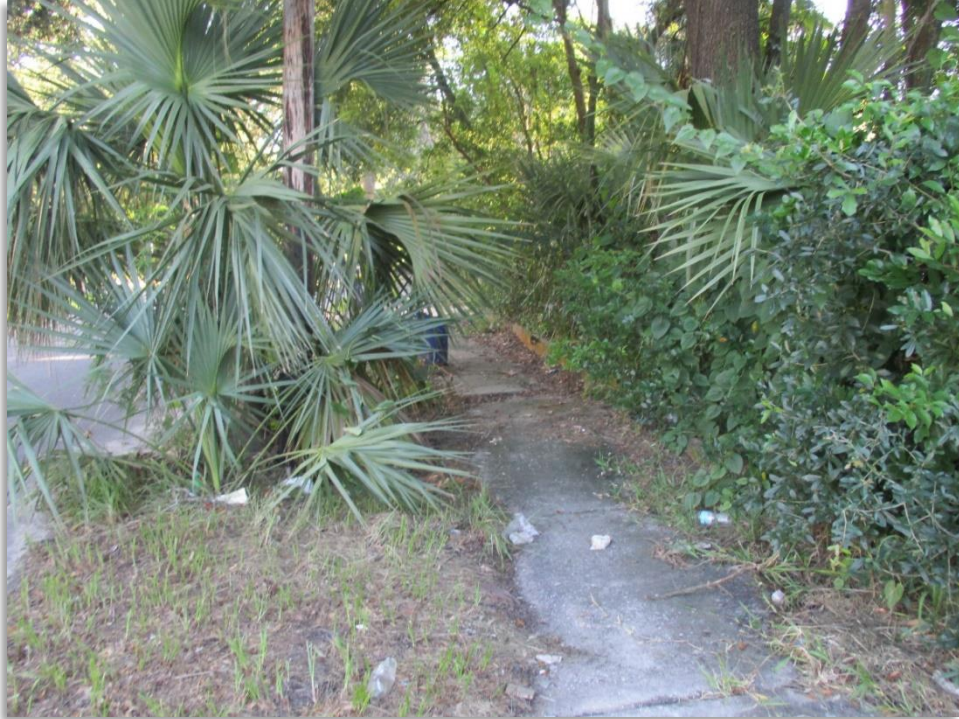
Figure 8: Overgrown landscaping blocking the sidewalk

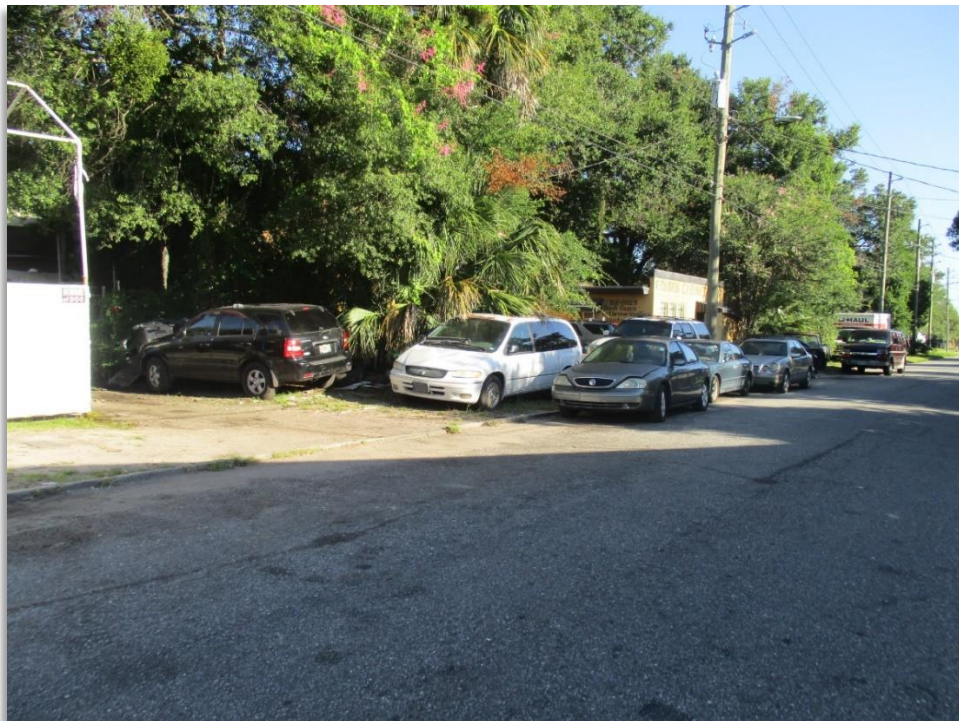
Figure 9: Vehicles parked on the sidewalk from a commercial property

- Increase code compliance enforcement

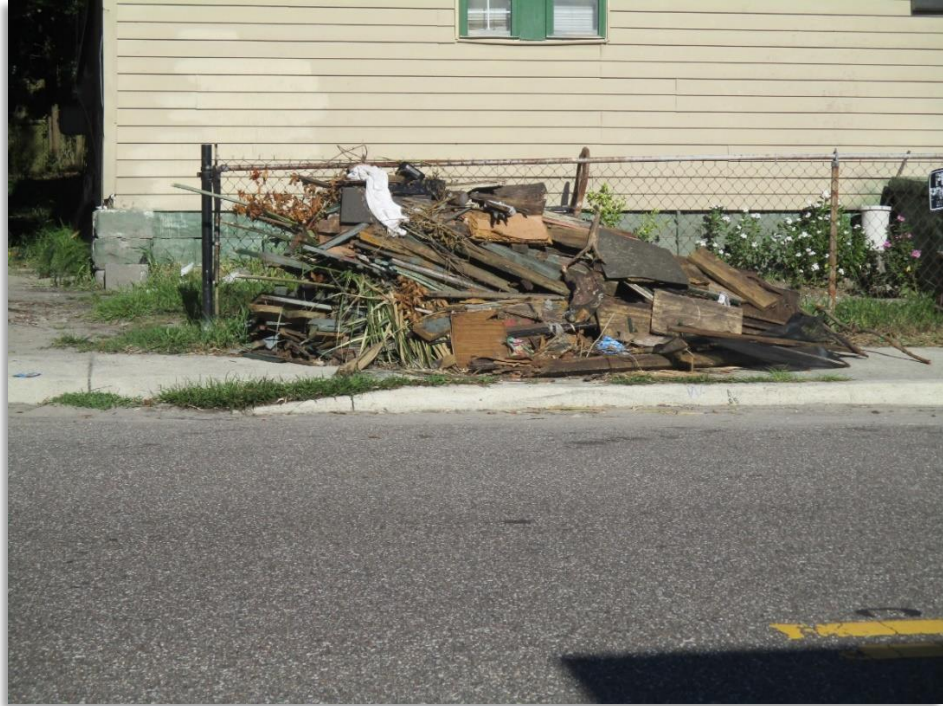
Figure 10: Trash blocking sidewalk

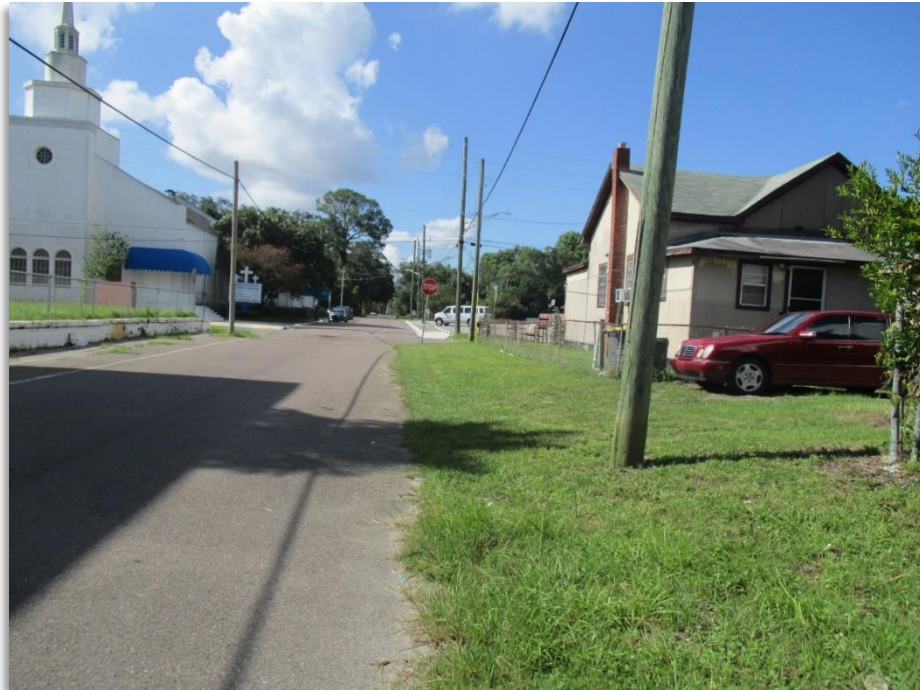
Figure 11: No sidewalks leading to church

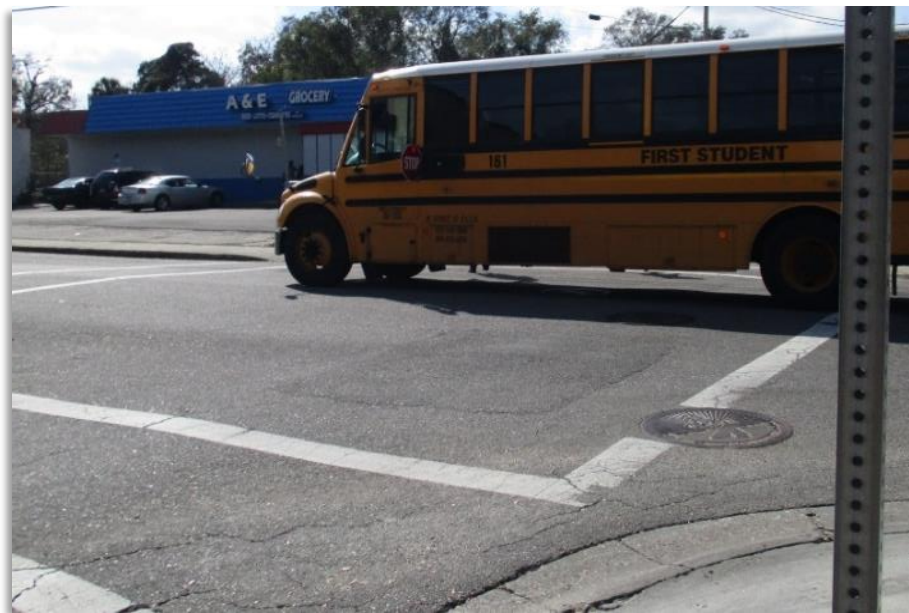
- The team observed a school bus come to a stop in the middle of an intersection to let students off right into the middle of the street (Figure 12).
- Drivers were observed speeding on 8th Street and 11th Street

Figure 12: School bus dropping students off in the middle of an intersection.

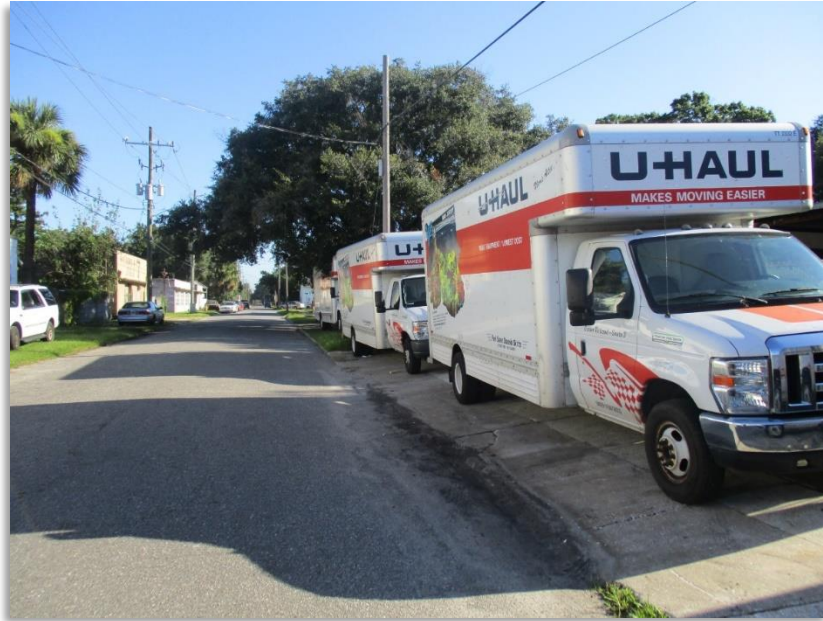
- People are parking vehicles on the sidewalks rather than in the street, especially on the southwest side of the neighborhood.

Figure 13: Commercial vehicles parked on the sidewalk.

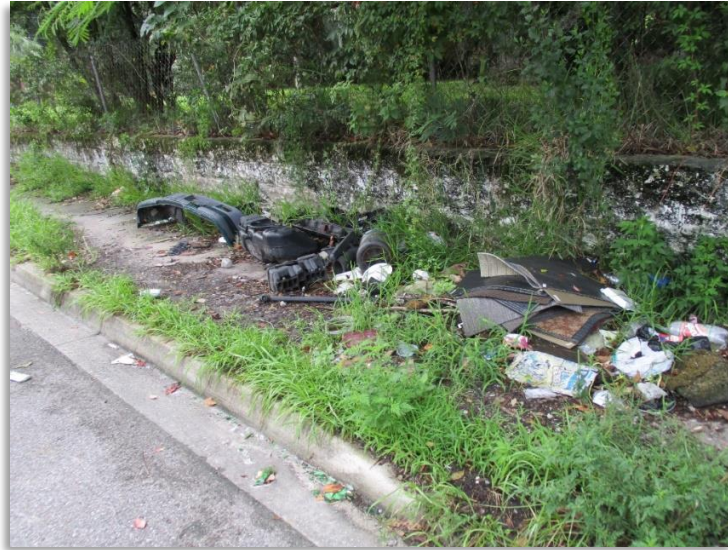
Figure 14: Trash with potentially sharp objects dumped on a sidewalk

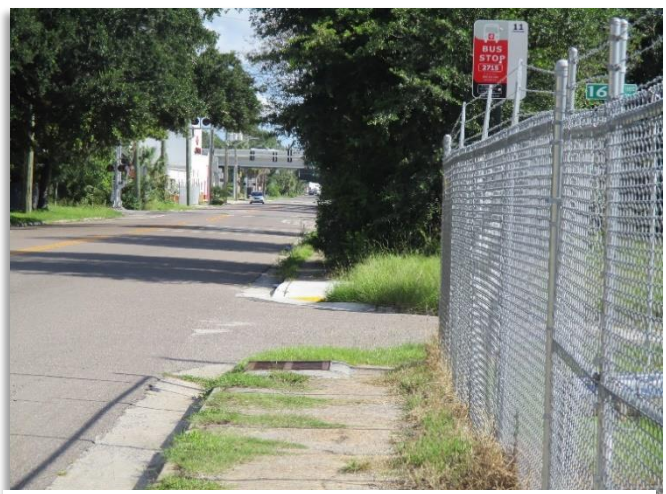
- Landscaping in the public right-of-way over the entire Study Area is either lacking or overgrown and littered with trash.
- None of the bus stops have shelters, and most do not have benches or lighting.
- The pedestrian overpass at Haines Street & Winthrop Street has some broken sidewalks and is need of trash pickup.
- The entire Study Area needs trash removal and landscape maintenance.

Figure 15: Bus stop with no, bench, shelter or lighting

- Plant shade trees in utility strip on both sides of Franklin Street between 12th Street & 8th Street
- Close extra/unused driveways on Phoenix Avenue where possible
- Work with the Jacksonville Transportation Authority to get shelters, benches, and lighting at all bus stops along Phoenix Avenue
- Widen the following bus stop pads along Phoenix Avenue into the street by 3 feet:
 - Southbound at 18th Street
 - Northbound at 17th Street
 - Northbound at 16th Street
 - Northbound at 13th Street

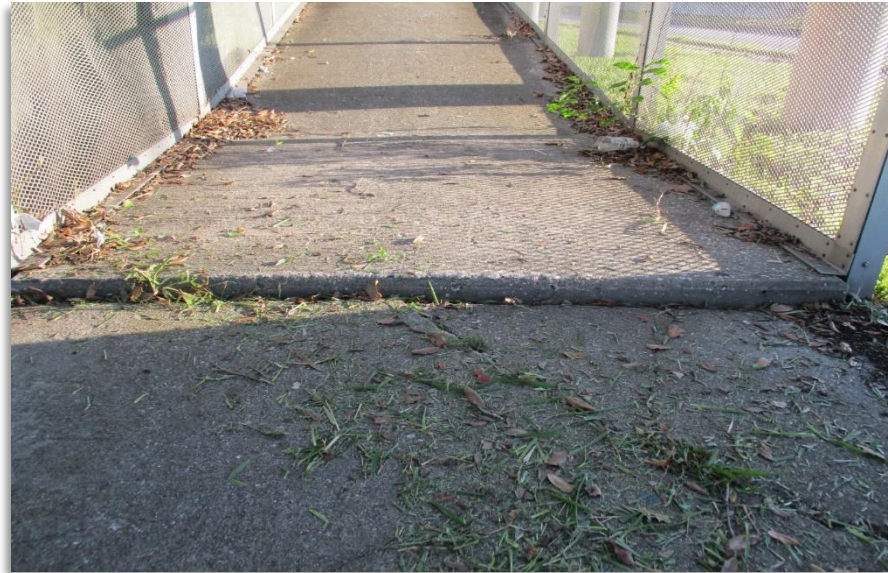
Figure 16: Broken sidewalk on pedestrian overpass at Haines Street and Winthrop Street

- Add lighting to pedestrian overpass at Kooker Park
- Pressure wash sidewalk on pedestrian overpass at Haines Street & Winthrop Street
- Implement one of these design improvements for Phoenix Avenue between 21st Street & Dyal Street:

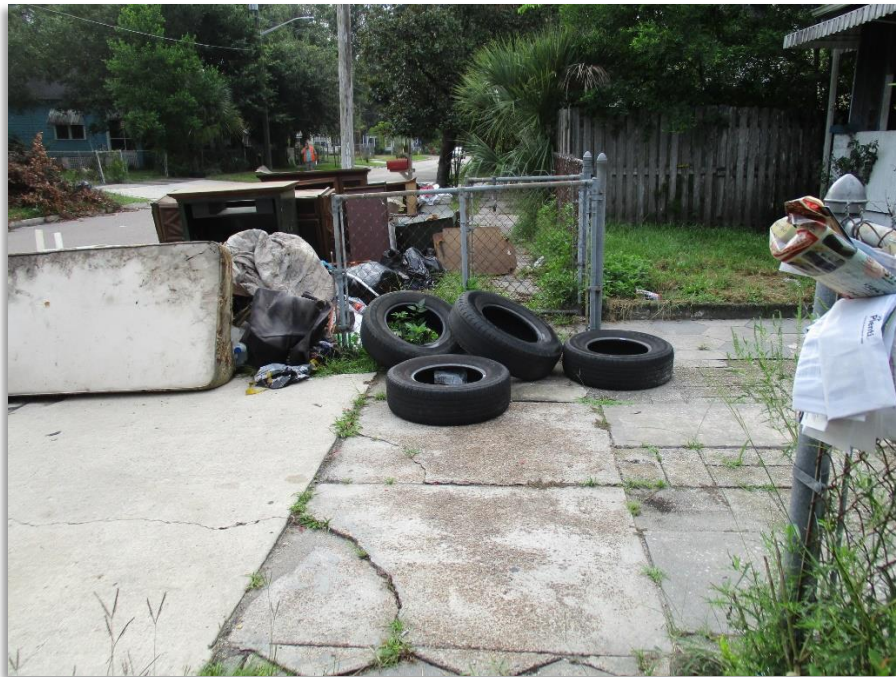
Figure 17: Trash blocking sidewalks is pervasive in the area.
