# Rogero Road Corridor Study

**Arlington Expressway to Merrill Road**

Final Draft Report

September 2023

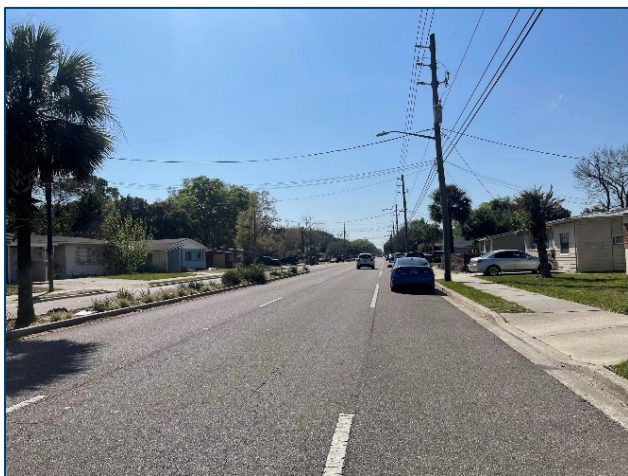
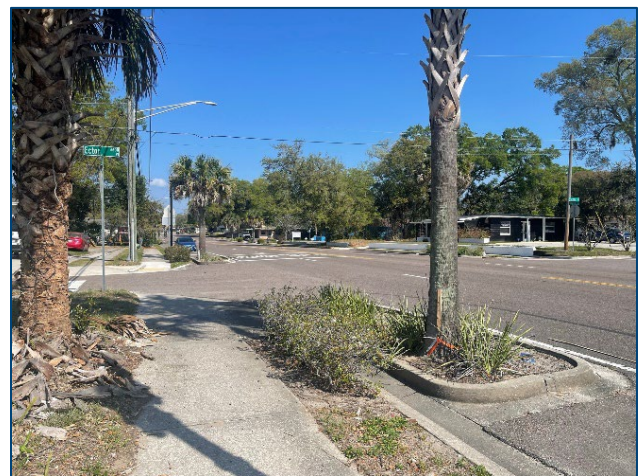
This segment is defined by frequent curb cuts serving single-family homes on the northern portion of Rogero Road and a mix of residential and commercial driveways on the southern portion, closer to Arlington Road. Approximately every other intersection is treated with decorative stamped asphalt and planted with sable palms. Approaches to the signalized intersections have dedicated left turn lanes and narrow raised landscaped medians.

*In Segment 2, Rogero Road has on street parking, spot median islands and landscaped bump outs at select intersections for traffic calming.*

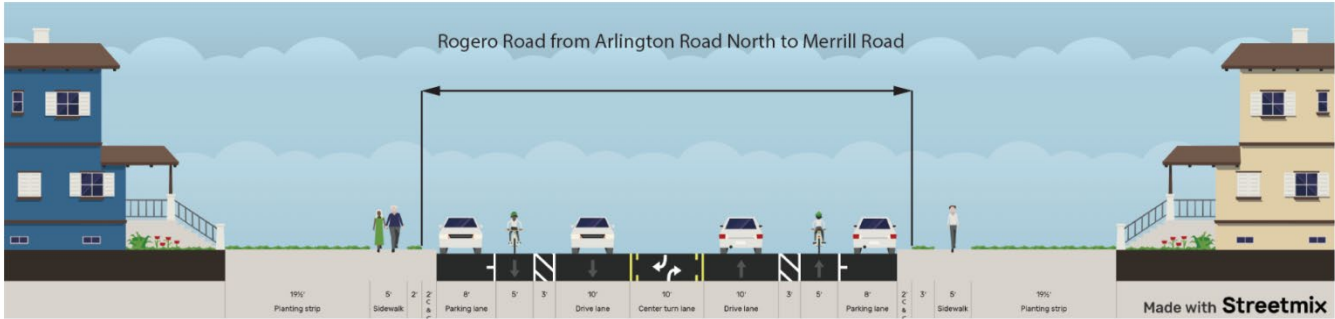
The study developed a lane repurposing concept, which included two travel lanes, a center two-way left turn lane, buffered bike lanes and on street parking.

*The lane repurposing concept includes buffered bike lanes and a two-way left turn lane. (Image: City of Jacksonville Planning and Development Department)*

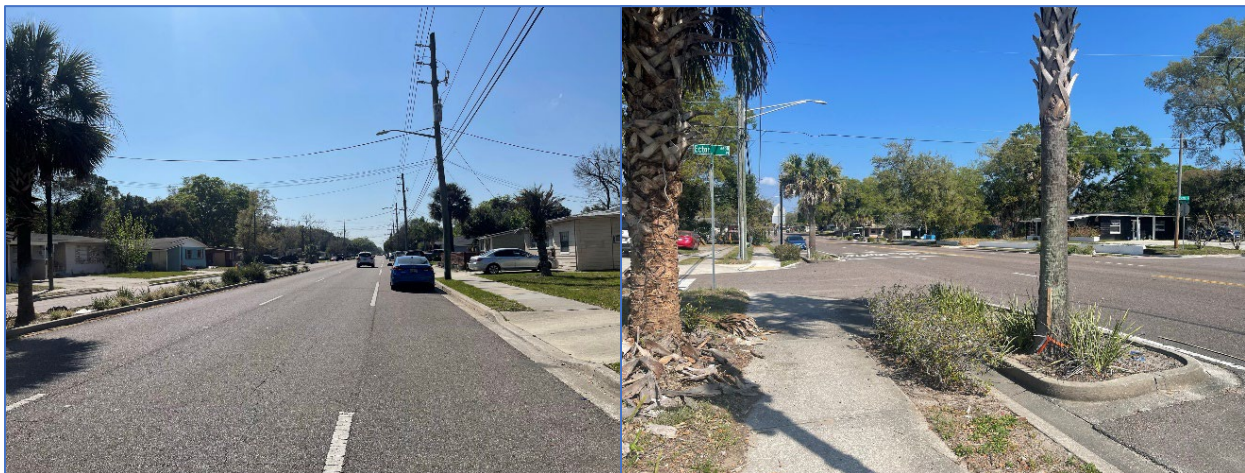
Segment 2 is defined by frequent curb cuts serving single-family homes on the northern portion of Rogero Road and a mix of residential and commercial driveways on the southern portion, closer to Arlington Road. Approximately every other intersection is treated with decorative stamped asphalt and planted with sable palms. Approaches to the signalized intersections have dedicated left turn lanes and narrow raised landscaped medians.

*In Segment 2, Rogero Road has on street parking, spot median islands and landscaped bump outs at select intersections for traffic calming.*

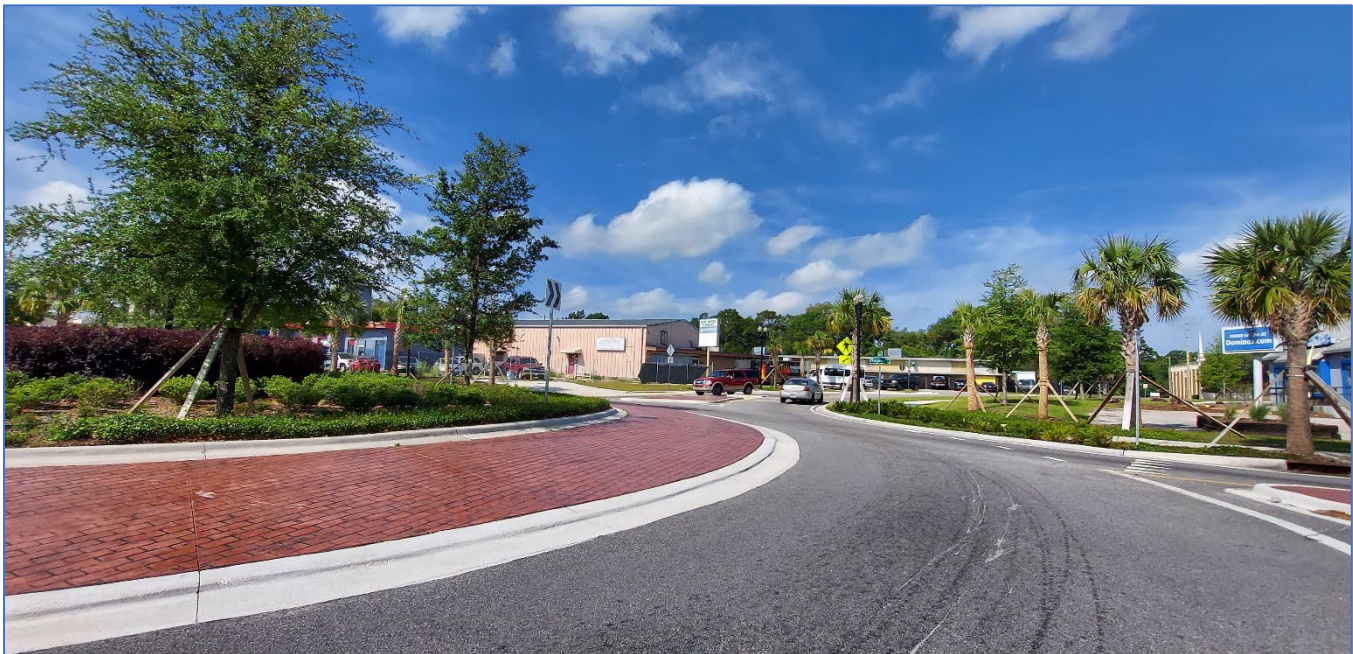
*The intersection of Arlington Road and Rogero Road has been reconstructed into a roundabout. In the background, a vehicle is seen exiting onto Groveland Drive.*

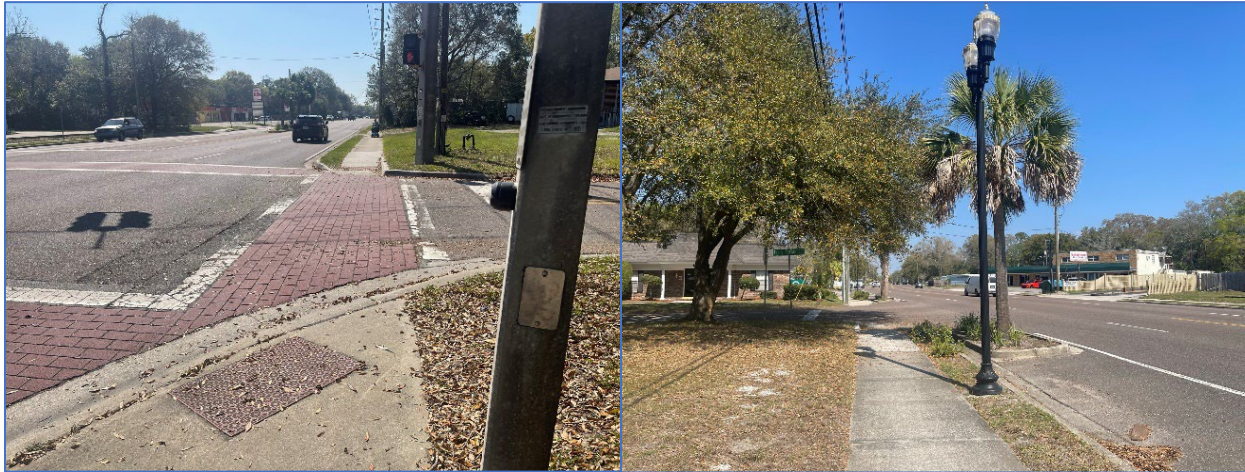
Marked crossings are spaced an average of 1,000 LF apart, with Gamewell Road acting as a distinct divider of crossing frequency. North of this roadway, marked crosswalks are separated by an average of approximately 1,300 LF, while crosswalks south of this point are separated by an average of approximately 580 LF. The crosswalks south of Gamewell Road also include landscaped bump outs (a.k.a. choker islands) as a traffic calming measure.

*Some intersections south of Gamewell Road in Segment 2 feature decorative stamped asphalt crosswalks and landscaped bump outs. There is also pedestrian scale lighting on both sides of Rogero Road throughout the studt corridor.*
